ENGINEERING STUDIES FOR A CONTRACT FOR FIELD
INVESTIGATION OF HIGH WATER DAMAGE
IN OSWEGO COUNTY, NEW YORK

Contract Number
DACW 23-75-C-0033

St. Lawrence-Eastern Ontario Commission
317 Washington Street
Watertown, New York 13601

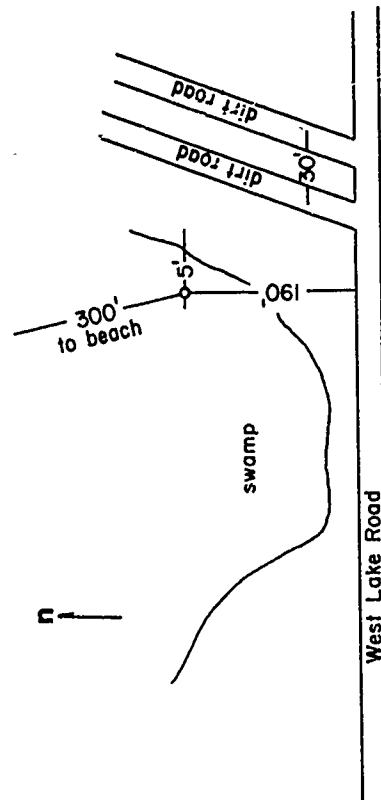
Mark Identification	Description Code	Date of Storm	Elevation Reached	Location	Remarks
Nail at water crest surrounded by ample white paint. Mark on N side of tree.	#1	*	**	Swamp between mileage posts 154.0 and 154.7 (about 154.35) North of West Lake Rd. (formerly Health Camp Road)	Mark located using start of moss on tree as a criteria. Diameter of tree is 1 foot. Mark is about 1 foot from base of tree.

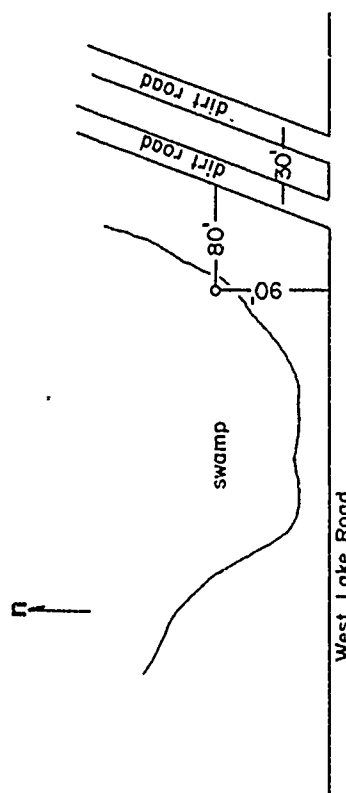
Mark Identification	Description Code	Date of Storm	Elevation Reached	Location	Remarks
Nail at water crest surrounded by ample white paint. Mark on E side of tree.	#2	*	**	Swamp between mileage posts 154.0 and 154.7 (about 154.35). North of West Lake Rd. (formerly Health Camp Road)	Mark located using start of moss on tree as a criteria. Diameter of tree is 0.6 feet. Mark is about 1 foot above base of tree. <u>New</u> moss on young tree.

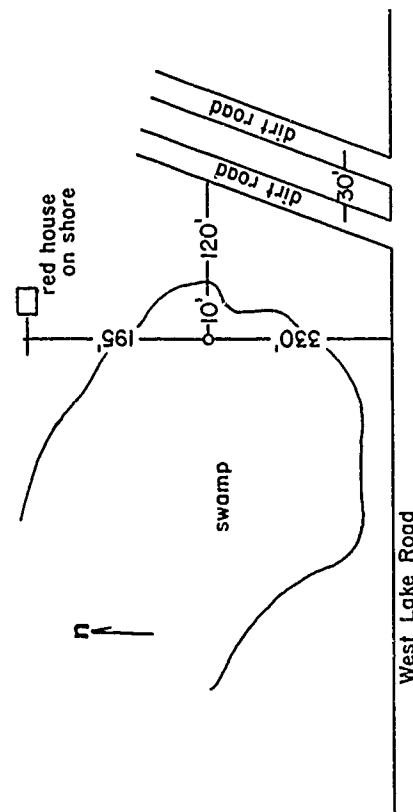
Mark Identification	Description Code	Date of Storm	Elevation Reached	Location	Remarks
Nail at water crest surrounded by ample white paint. Mark on E side of tree.	#3	*	**	Swamp between mileage posts 154.0 and 154.7 (about 154.35). North of West Lake Rd. (formerly Health Camp Road)	We located mark using start of moss on tree as a criteria. Diameter of tree is .4 feet (Maple tree). Location is 140' North of #1 high water mark. Mark is about 1 foot above base of tree.

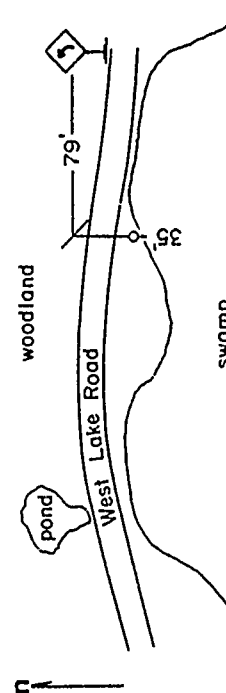
Mark Identification	Description Code	Date of Storm	Elevation Reached	Location	Remarks
Nail at water crest surrounded by ample white paint. Mark on S side of tree.	#4	*	**	Swamp located between mileage posts 154.0 (about 154.4) and 154.7. South of West Lake Road (formerly Health Camp Road)	Mark located using start of moss on tree as a criteria. Diameter of tree is 0.4'. Mark about 1 foot from base of tree.

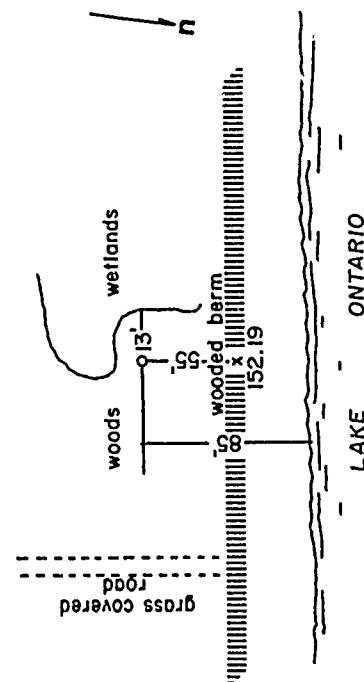
Mark Identification	Description Code	Date of Storm	Elevation Reached	Location	Remarks
Nail at water crest surrounded by ample white paint. North side of tree marked.	#5	*	**	Snake Swamp, mile post 152.19, 1.2' diameter tree located 85' perpendicular from lake shore and 55' from berm crest; 13' east of wetlands, accessible only by walking on grass cove red road west of Dowie's Grove.	Mark is abrupt start of moss 1.4' above ground, many trees in area show same natural markings.

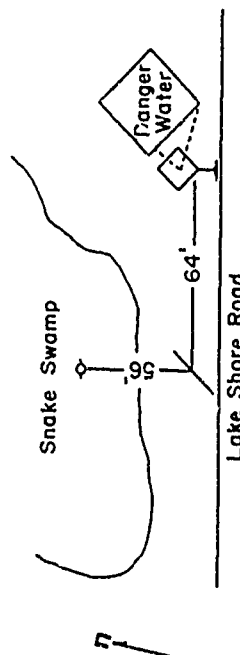
Mark Identification	Description Code	Date of Storm	Elevation Reached	Location	Remarks
Nail at water crest surrounded by ample white paint. North side of tree marked.	#6	*	**	Snake Swamp, marked tree is between mile posts 152 and 153 (about 152.45) on east side of swamp, the tree has 3 trunks and nail is in center one. (0.6' diameter trunk) the tree is 64' West of road sign (Danger Water) and 56' North of sign on Lake Shore Road. The sign is on the Northside of road.	Mark is abrupt start of moss on tree.

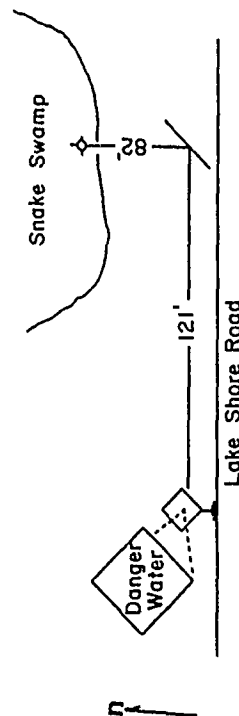
Mark Identification	Description Code	Date of Storm	Elevation Reached	Location	Remarks
Nail at water crest on south side of tree, surrounded by ample white paint.	#7	*	**	Snake Swamp, marked tree is between mileage posts 152 and 153 (about 152.7), 0.9' diameter tree; the marked tree is 121' east of "Danger Water" road sign located on south side of road and 82' North into the swamp, this location is approximately 1000' West of the first location on Lake Shore Road.	Mark is abrupt start of moss.

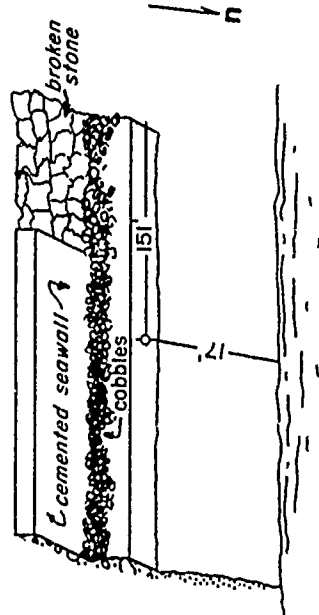
Mark Identification	Description Code	Date of Storm	Elevation Reached	Location	Remarks
Chisel mark on lower seawall surrounded by white paint.	#8	*	**	Mileage 146.5, 105 feet from end of seawall.	Determined by storm berm crest level to lower seawall. A second high water mark was determined by a minor storm berm crest formed 5/27/75, this high water mark is 2.2 feet below the first high water mark.

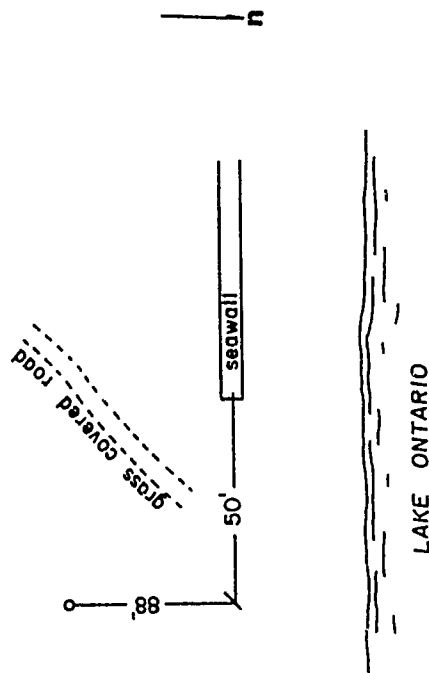
Mark Identification	Description Code	Date of Storm	Elevation Reached	Location	Remarks
Nail at crest of water mark surrounded by ample white paint on north side of tree.	#9	*	**	Mile post 146.0, on west side of swamp. It is 50' east of seawall and 88' back into swamp.	The tree was a maple tree, mark was 1.5' above base of tree, multi-trunk tree (1.8' diameter), marked trunk is .8' in diameter. The identifying mark was the abrupt start of moss on the tree.

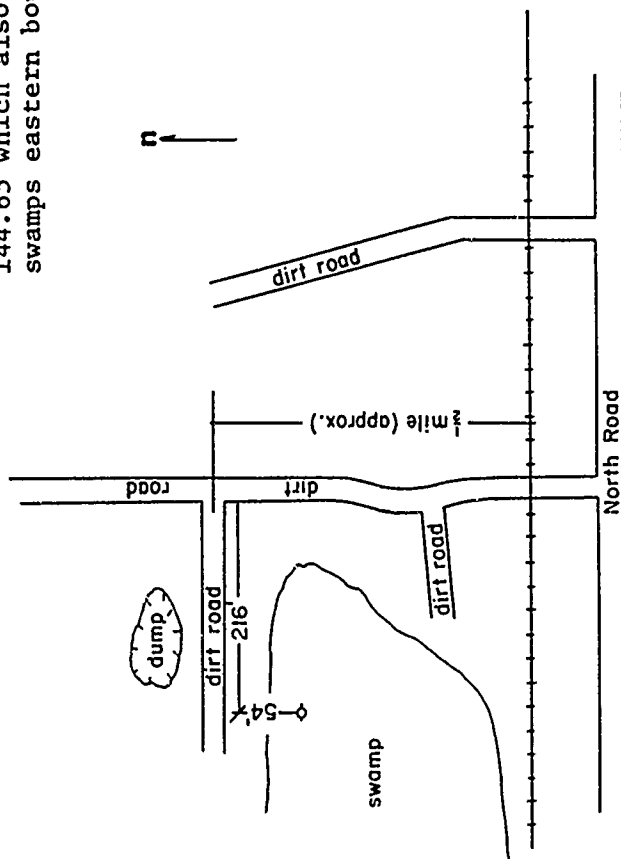
Mark Identification	Description Code	Date of Storm	Elevation Reached	Location	Remarks
Nail at water crest surrounded by ample white paint. On North side of maple	#11	*	**	Dirt Road at mileage post 144.65 which also parallels swamps eastern boundary.	Mark located abrupt start of moss on 0.8' diameter maple tree. Mark is about 1.0' from base of tree.

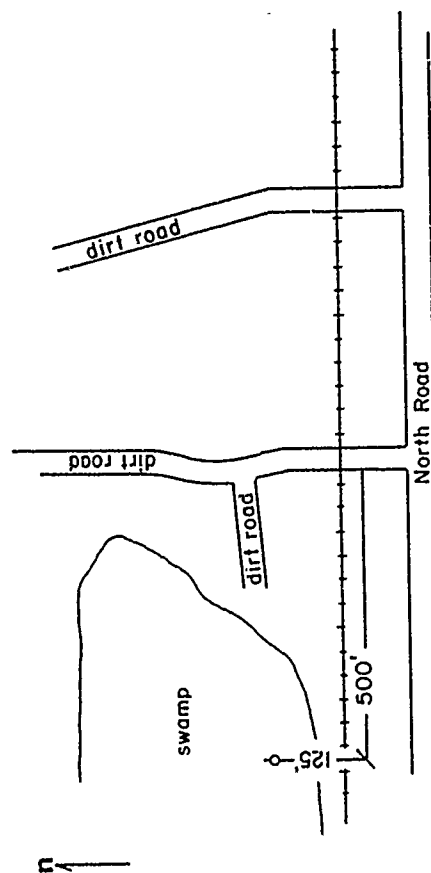
Mark Identification	Description Code	Date of Storm	Elevation Reached	Location	Remarks
Nail at water crest surrounded by ample white paint on South side of tree.	#12	*	**	Dirt road at mileage post 144.65 which also parallels swamp's eastern boundary.	Mark located using abrupt start of moss on 1.1' diameter tree, type unknown. Mark is about 0.9' from base of tree.

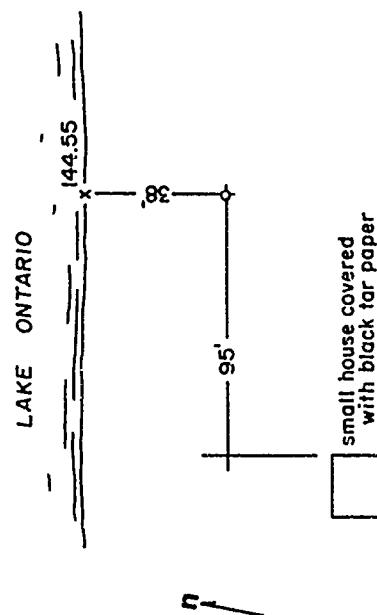
Mark Identification	Description Code	Date of Storm	Elevation Reached	Location	Remarks
Nail at crest of high water mark surrounded by ample white paint on north side of tree. Trunk of tree 1.3' in diameter.	#13	*	**	Mileage 144.55, 38' from lake shore, 7 feet above lake level; second high water mark 2' below this, 95 feet east of small house covered by black tar paper.	High water mark was determined by high berm crest caused by storm waves. Second high water mark determined by a lesser storm berm 5' above lake level.

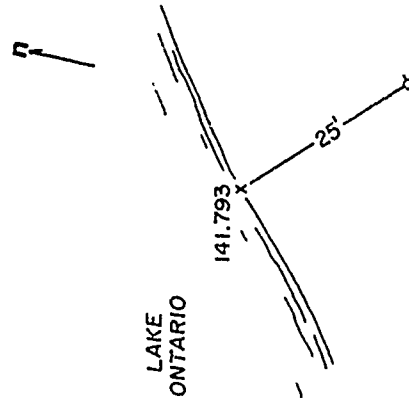
Mark Identification	Description Code	Date of Storm	Elevation Reached	Location	Remarks
Nail on west side of tree at crest of high water mark surrounded by ample white paint. The tree had a 1.4 foot diameter.	#14	*	**	Mileage 141.793, 25 feet from shore.	First high water mark determined by storm berm crest. Second high water mark 1.3 feet below first high water mark was determined by lower swash bar.

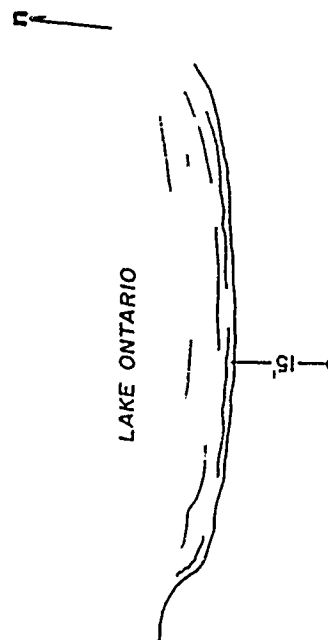
Mark Identification	Description Code	Date of Storm	Elevation Reached	Location	Remarks
Nail at high water crest on north side of maple tree surrounded by white paint.	#16	*	**	Mileage 137.41, the tree is 15 feet from the waters edge.	High water mark determined by storm berm crest 6 feet high (above lake level); 1.5 foot diameter tree.

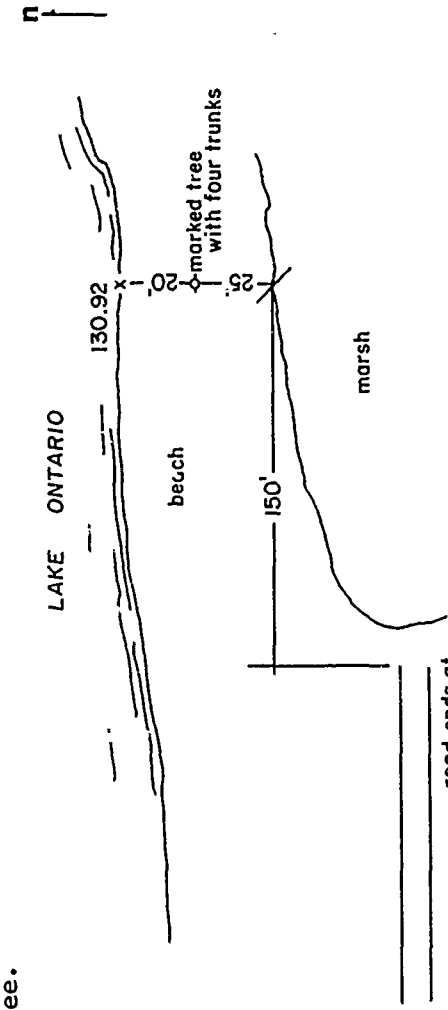
Mark Identification	Description Code	Date of Storm	Elevation Reached	Location	Remarks
Nail at berm crest surrounded by ample white paint. On West side of a multi-trunked tree.	#17	*	**

On berm crest where there is a tree that branches into 4 trunks. On the trunk to the south on west side of it is the mark. Diameter of trunk with mark is 1.3 ft.

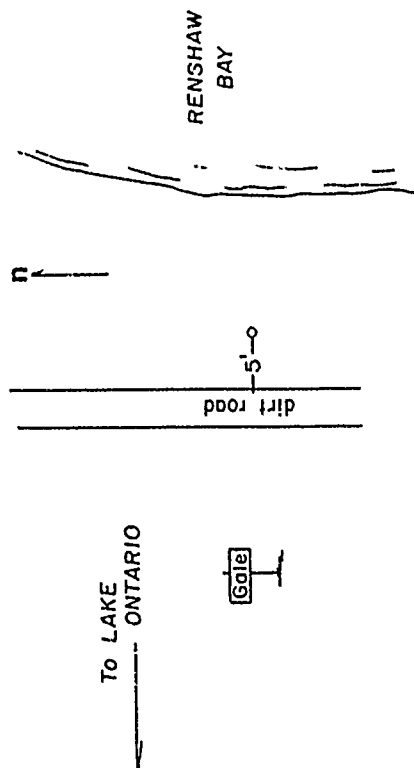
Mark Identification	Description Code	Date of Storm	Elevation Reached	Location	Remarks
Red paint line at base of tree (Maple). Sign on tree indicating high water mark.	#18	*	**	At mileage 120.15 opposite the Gale Property on west side of Peninsula at North Pond.	Found on west side of Dirt Road on 1.0 ft. diameter Maple tree.
